**JORDAN VALLEY WATER TREATMENT PLANT FILTER AND CHEMICAL UPGRADES**

**CONTRACT/TECHNICAL SPECIFICATIONS**

**VOLUME 5 OF 6**

**APPENDICES**

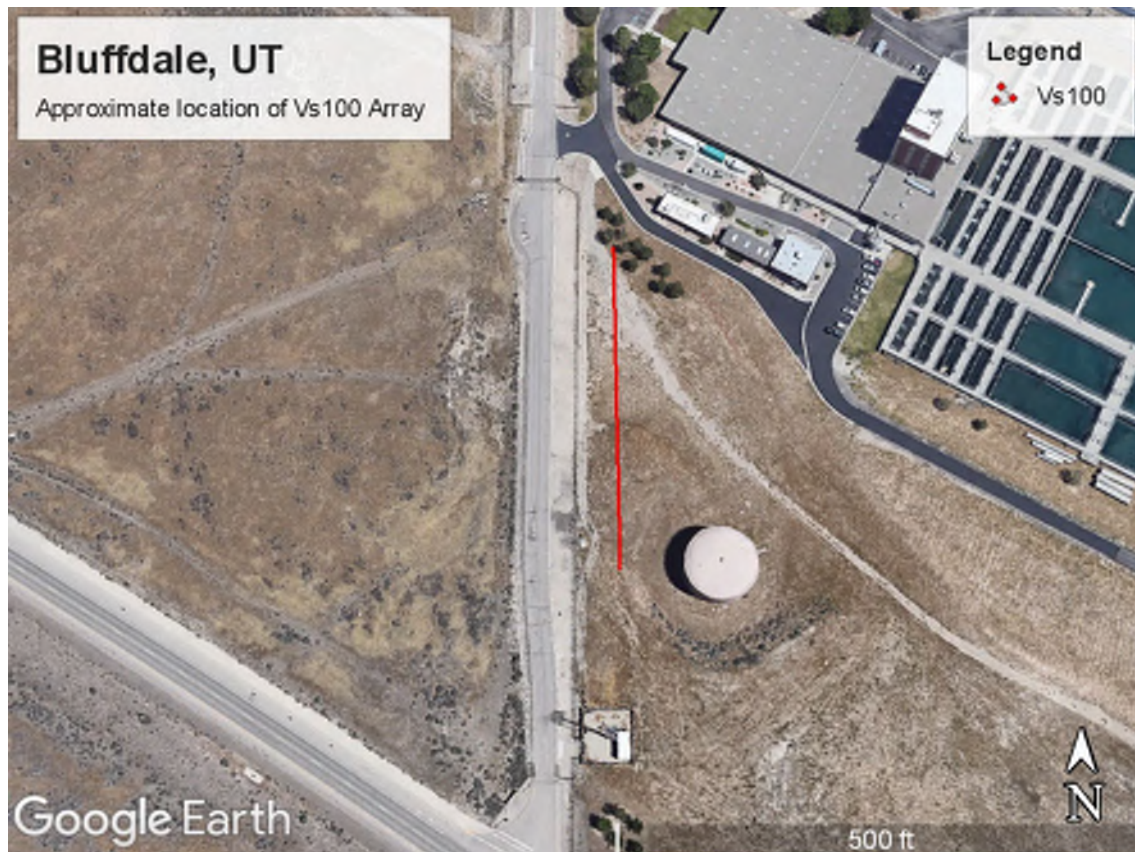
Figure 1: Shear wave velocity ( $V_{s100}$ ) survey at the water treatment facility in Bluffdale, UT The test array length is 377 ft.

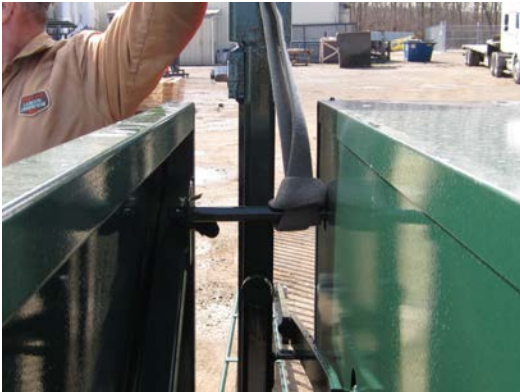
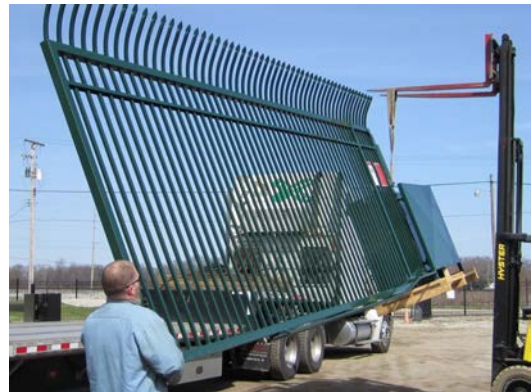
To lift Gate & Operator, (Crane, Front End Loader, Forklift or Wrecker with Telescoping Boom) use a lifting strap. The strap should be secured around Operator Arm and T/M Safety Pin or the top rail of the gate near the operator arm. (See Dwg. #103).

**NOTE:** It is recommended to attach Gate to Operator Arm **before** lifting (for better balance), but it is not mandatory. If using a Forklift to position Operator only, lift from *sides only*! **Do not try to lift gate and operator together from the side** (See Dwg. #103).
